Smoke and Dye Testing Summary

High Level Sewershed

Test ID	Test Type	Date Inspected	Company / Super.	Blower MH	Ground Condition	Notification Made?	Total Length
S1028-172	Smoke	7/20/2009	ADS/TM	S09QQ_018MH	Dry	Yes	1,104.19

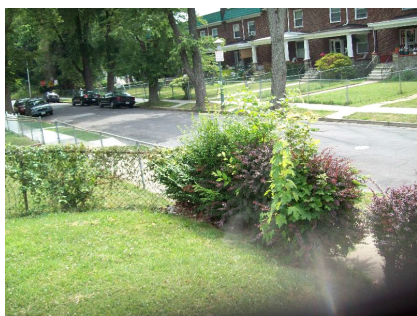
Picture \S1028-172-OB01-P01.jpg

Source Cleanout

Location Yard - front

Comments Smoke from cleanout in front yard. 3308 Alto Rd.

Comments Front yard, 3308 Alto Rd.

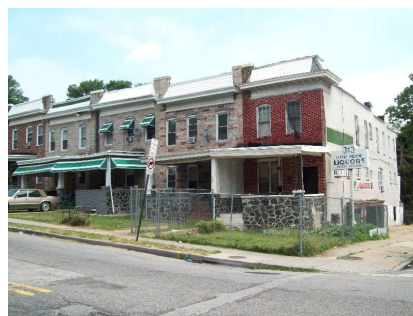
Picture \S1028-172-OB02-P01.jpg

Source Catch Basin

Location Curb

Comments Smoke from catch basin along curb. 2601 Hilton St.

Comments Front of house, 2601 Hilton St.

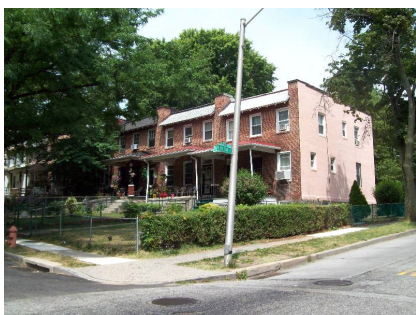
Picture \S1028-172-OB03-P01.jpg

Source Catch Basin

Comments Smoke from catch basin along curb on the northwest corner of Hilton St. & Piedmont Ave.

Comments Hilton St. & Piedmont Ave.
looking northwest

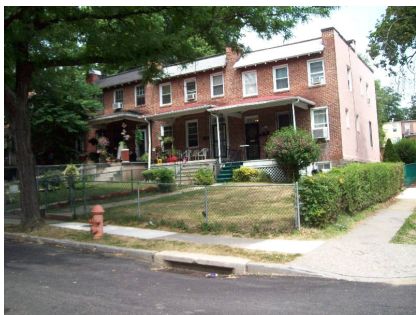
Picture \S1028-172-OB05-P01.jpg

Source Catch Basin

Comments Smoke from catch basin along curb. 3300 Piedmont Ave.

Comments Front of house, 3300 Piedmont Ave.

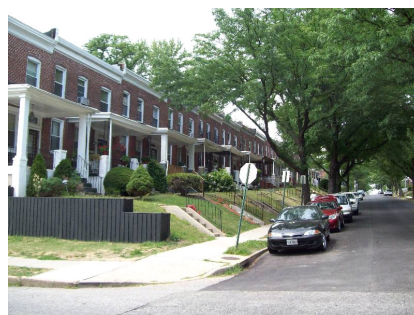
Picture \S1028-172-OB04-P01.jpg

Source Catch Basin

Comments Smoke from catch basin along curb. 3301 Piedmont Ave.

Comments Front of house, 3301 Piedmont Ave.
